## TECHNICAL SERVICE BULLETIN

### Level 3 Charging, Illuminated Charger Service Required Indicator In The IPC And/Or Multiple DTCs

**23-2014**01 March  
2023

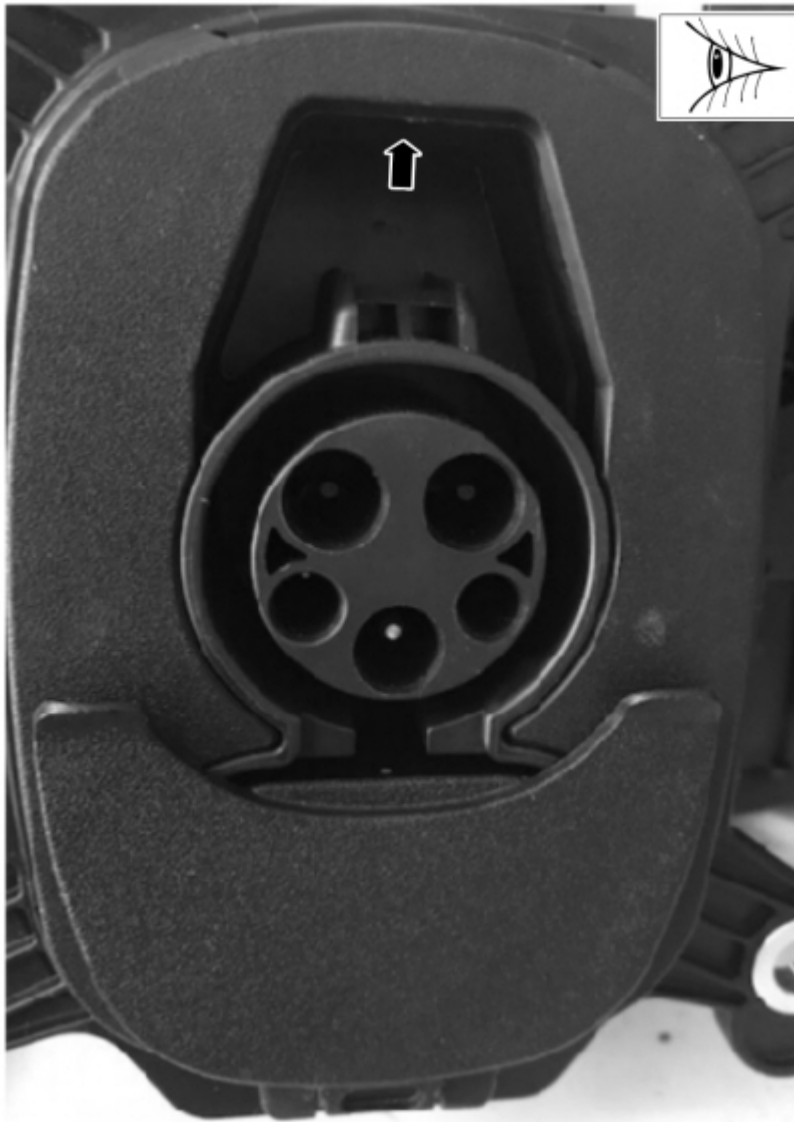
Figure 2

1. Inspect the charge port lock actuator pin. (Figure 2) Is the charge port lock actuator pin missing or loose?
