# TECHNICAL SERVICE BULLETIN

## Audio System Inoperative Or No Access To FM, AM Or Satellite Radio Modes - Built on or Before 06-Jan-2023

23-2116

Ford 2022 Expedition	Built on or before 28-Oct-2022
2022-2023 F-150 Lightning	Lariat/Platinum trim levels Built on or before 06-Jan-2023

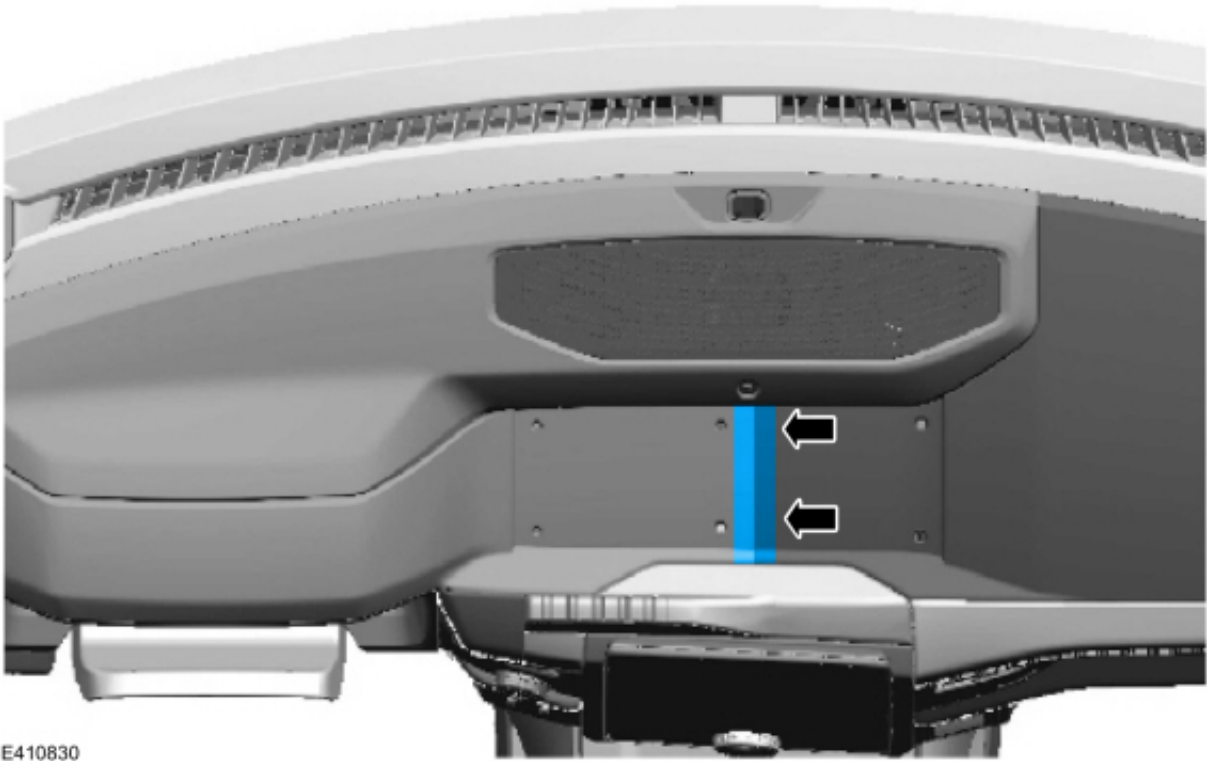
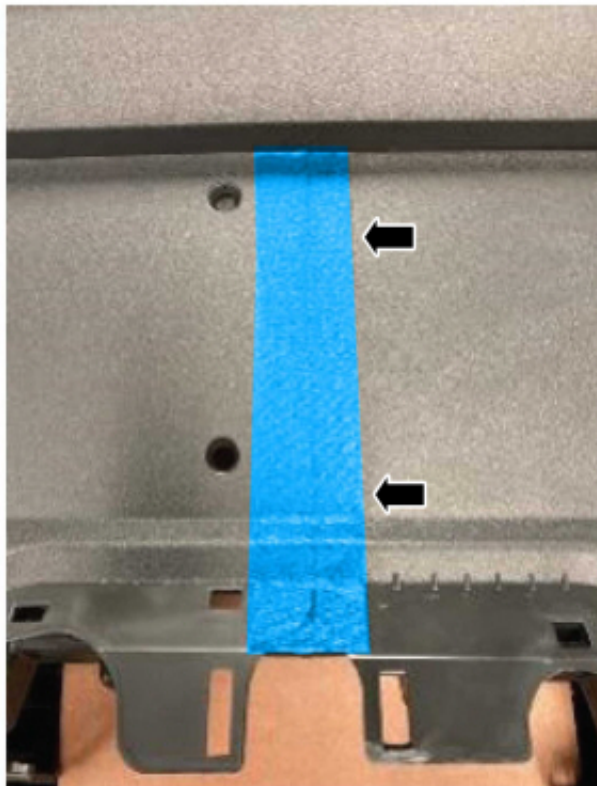
**Issue:** Some 2022-2023 F-150 Lightning vehicles with Lariat/Platinum trim levels built on or before 06-Jan-2023 and 2022 Expedition vehicles built on or before 28-Oct-2022 may exhibit a concern with the audio system inoperative or no access to FM, AM or satellite radio modes. This may be due to liquid ingress in the audio front control module (ACM) from the top of the dash area. To correct the condition, follow the Service Procedure to replace the ACM and seal the dash seam.

3. Clean the areas where seal tape will be installed on the dash seam in Figures 2-3 and on the underside of the dash in Figures 4-5 by wiping with a clean damp cloth and then wiping a second time with clean cloth that is damp with isopropyl alcohol.

4. Install 1 piece of 165 mm x 35 mm (6.5 in x 1.4 in) seal tape on the dash seam as indicated in Figures 2-3.
5. Cut 1 piece of seal tape to 35 mm (1.4 in) long.
6. Install a piece of 35 mm x 35 mm (1.4 in x 1.4 in) seal tape on the underside of the dash to cover the bottom of the locator hole indicated in Figures 4-5.
7. Reinstall the instrument panel storage tray mat.
