# TECHNICAL SERVICE BULLETIN

## Gear Shift Module (GSM) Concerns

25-2579

<b>Ford</b> 2021-2025 F-150	Built on or before 08-Sep-2025 Console shift
--------------------------------	---

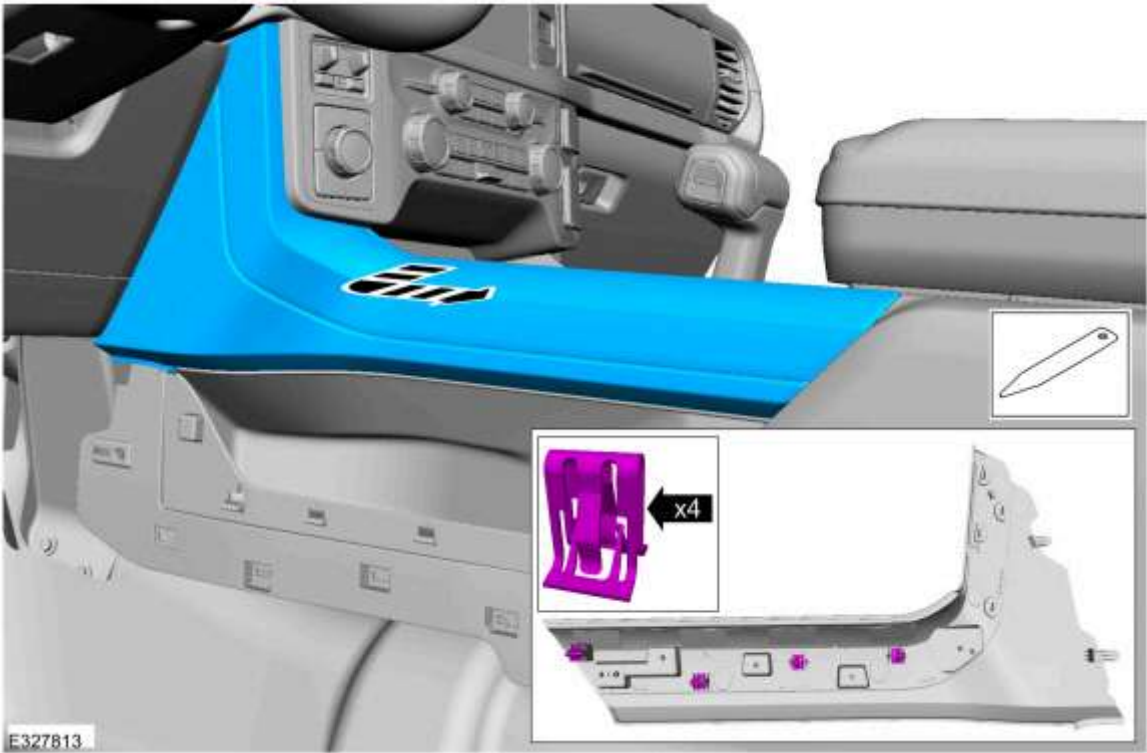
Figure 1

- With the system in Ready to Drive mode/engine running, apply and release the brake pedal while observing BRK\_PDL\_SW2 PID in the BCM. Does the BRK\_PDL\_SW2 PID change status when the brake pedal is pressed and released?
  - Yes - proceed to Step 2.
  - No - diagnose the brake pedal switch output and repair outside of this article. Refer to WSM, Section 307-05.
- Is the vehicle built on or before 08-Sep-2025?
  - Yes - proceed to Step 3.
  - No - This article does not apply. Refer to WSM, Section 307-05.
- Remove the left console trim to inspect the GSM build date. Refer to WSM, Section 501-12. (Figure 1)
