## CERTAIN 2022-2023 MODEL YEAR F-150 LIGHTNING EQUIPPED WITH INTELLIGENT BACKUP POWER FEATURE — UPDATE THE AUXILIARY PROTOCOL INTERFACE MODULE (APIM), GATEWAY MODULE (GWM) AND TELEMATICS CONTROL UNIT (TCU) SOFTWARE

### SERVICE PROCEDURE

### Module Programming

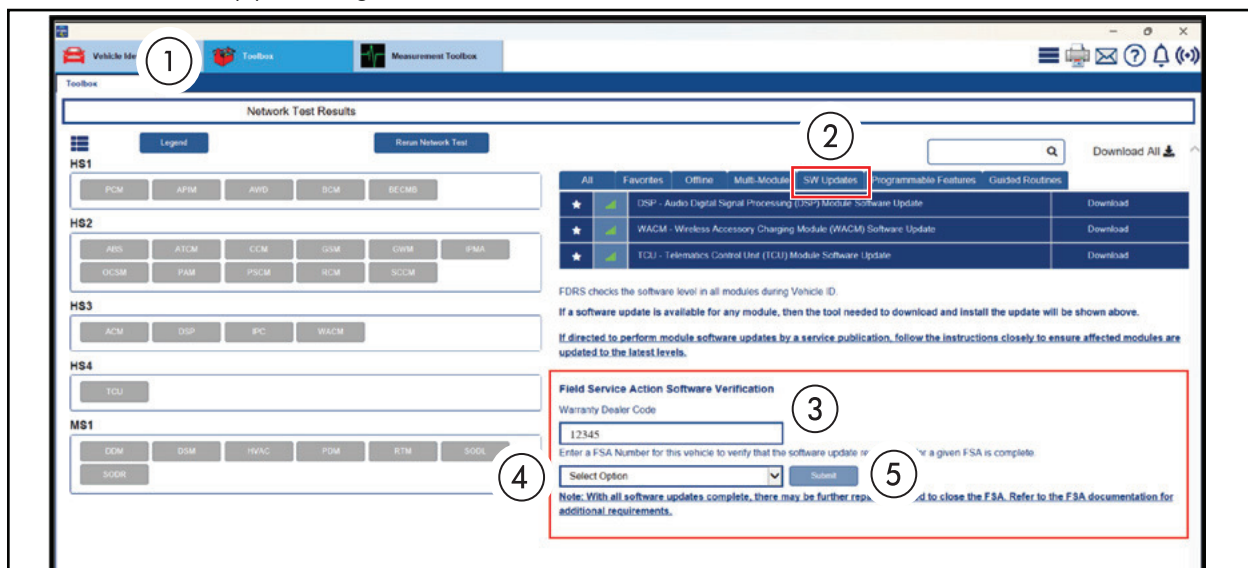
FIGURE 1

29. From the list on the RH side of the screen, select **Self-Test** and click **RUN**.
30. Click the **Run Selected Tests** button in the lower right.
31. Click the **Clear & Retest** button at the top of the screen to clear Diagnostic Trouble Codes (DTCs) in all modules.
32. This FSA requires a **Software Verification Approval Code** after performing the software update. Please follow the instructions below to obtain the approval code. The claim will not be paid and the FSA will remain open if a Software Verification Approval Code is not provided. For more information, see EFC 17526.
33. Select the **SW Updates** tab (1). See Figure 1.
34. **Warranty Dealer Code** (2) - Change the displayed PA code as necessary. See Figure 1.
35. Select the **FSA** (3) from the drop-down menu. See Figure 1.
36. Select **Submit** (4). See Figure 1.
